BLAZE® TREATED GAS LIFT MANDRELS SOLVE CORROSION-EROSION ISSUES IN BAKKEN

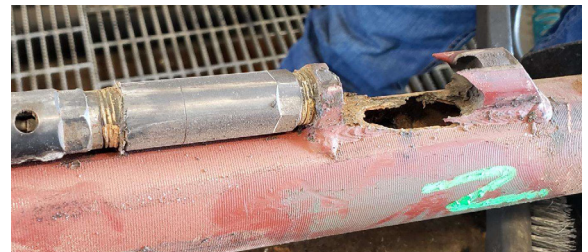
An operator in the Bakken was experiencing **short run times due to failed mandrels after ~6 months** on 5 of 6 affected wells. Corrosion, primarily H₂S, in the lug and mandrel body behind the Gas Lift Valve (GLV) port was the culprit. **The operator looked to Endurance Lift for a solution as workover costs of ~\$60K and an average of 6 days of lost production (5,520bbl/oil, 13,800mmcf) were adding up.**

Conventional GL Mandrel showing corrosion-erosion of the Lug/GLV port after 6 month run time.

Endurance Lift introduced **BLAZE Gas Lift Mandrels** for the bottom 5 valves to address these challenges.

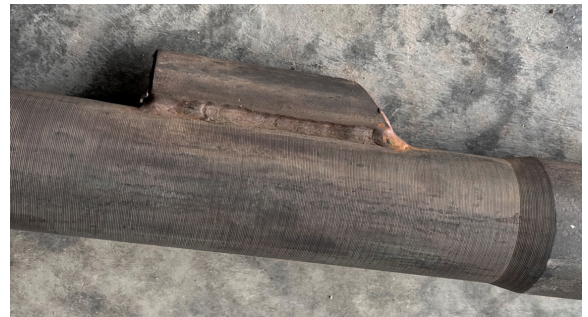
After 8.5 months, over 2 months longer than the previous average failure times, the systems were proactively pulled for frac protect, providing ELS and the operator a chance to inspect the parts. **The BLAZE treated mandrels** (lugs and mandrel bodies) **showed ZERO corrosion-erosion.**

BLAZE treated GL Mandrel showing no corrosion-erosion of the Lug/GLV port after 8.5 month run time.
