BLAZE TREATED ROD PUMP ACHIEVES MORE THAN 3X RUN LIFE IMPROVEMENT

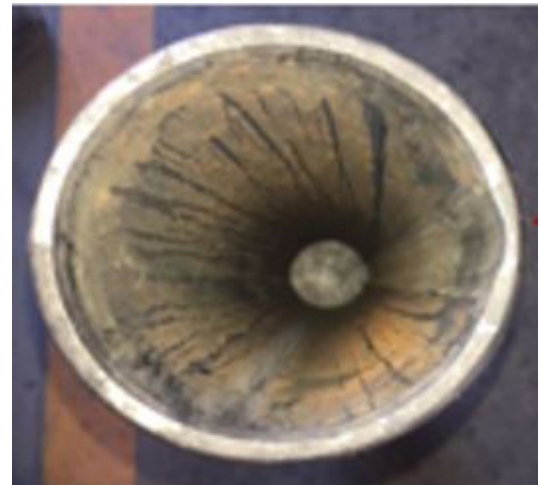
Customer utilized a **BLAZE-treated pup joint, a plunger swivel and a Blaze treated barrel bushing** to reduce the friction in the deviated portion of the wellbore. The pump continued to run until 2/07/2019, when the well was pulled for an unrelated issue. The BLAZE parts were inspected and found to have very minimal wear and were redeployed back into the well.

Photo of BLAZE-treated pup joint after 16 month run time.
