BLAZE TREATED CONTROL VALVE ACHIEVES 50X RUN-LIFE INCREASE

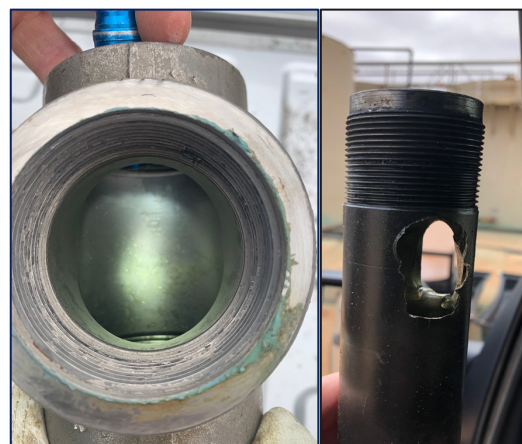
Left: Blaze treated Tee after December 2020 inspection.
Right: Damaged cage during December 2020 offset frac.

- **January 2, 2020:** Operator installed Blaze treated BPRV.
- **February 21, 2020:** 51 days of run life. The component was inspected and in great shape; re-installed. 37,700bbls of oil and 122,500bbls water produced to date.
- **July 28, 2020:** 209 days of run life. The component was inspected and in very good condition; re-installed. 272,000bbls of oil, 435,000bbls of water and 196,000Mcf produced to date.
- **December 4, 2020:** 337 days of run life. The cage (pictured) was damaged due to offset frac. The component was inspected and still in good condition; re-installed.
