BLAZE TREATED PLUNGERS ACHIEVE 189% AVERAGE RUN TIME IMPROVEMENT

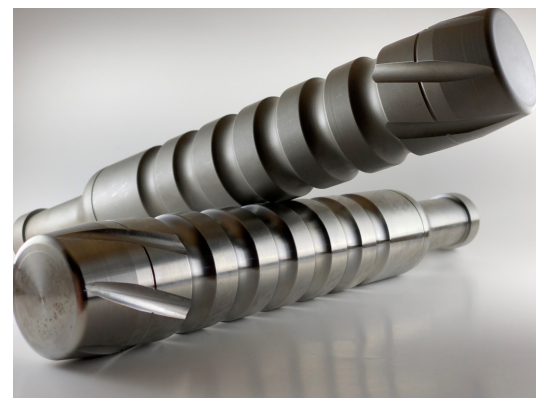
BLAZE treated barstock (top) with a non-treated barstock (bottom).

All three **Blaze treated plungers** achieved greater cycles and run life results than the previous non-treated plungers. At the time of publication, two of the three Blaze treated plungers continue to operate. The third was pulled for an unrelated issue.
