BLAZE TREATED PLUNGERS EXCEED EXPECTATIONS IN 8 WELL TRIAL

PROJECT DESCRIPTION

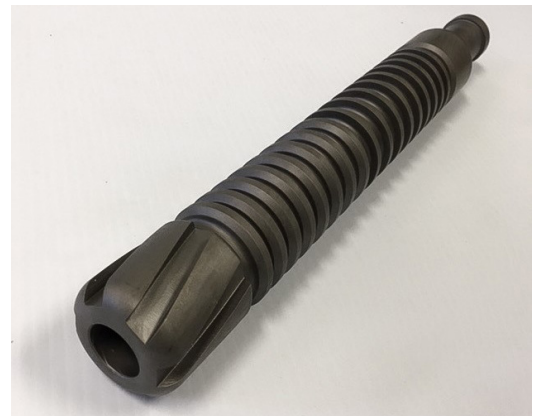
Blaze treated barstock.
