BLAZE TREATED TRIM KITS EXTEND RUN LIFE IN 3 WELL TRIAL

PROJECT DESCRIPTION Location Piceance Basin Image: Control of the second second

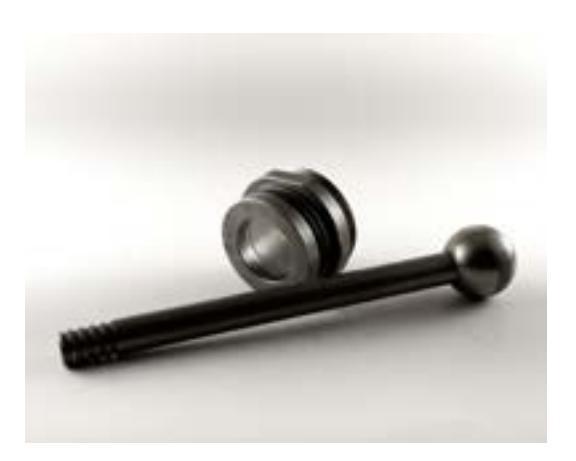
BLAZE treated trim kit.

Lift Type:	Plunger Lift
Well 1 (Carbide/BLAZE):	21 Days / 92 Days+
Well 2 (RF85/BLAZE):	24 Days / 127 Days+
Well 3 (Carbide/BLAZE):	7 Days / 39 Days
