BLAZE TREATED MOTOR VALVE EARNS NICKNAME WITH 3X RUNTIME IMPROVEMENT

PROJECT DESCRIPTION

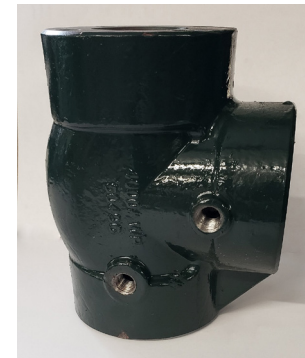
Western Motor Valve Body ID Cast after the Blaze treatment process. The ID of the part is unchanged by the Blaze treatment process.
